Manhole Inspection Summary

Manhole # S67C__002MH

Location Address: **110 Kane ST**

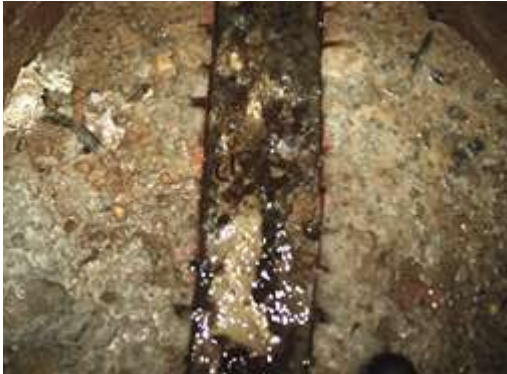
Defect 4

Bench ☒ Exists Material: **Brick and Stone** ☐ Parged
Condition: ☐ Sound ☐ Cracked ☐ Root Intrusion ☐ Deteriorated ☐ Leaks ☒ **Debris**

debris

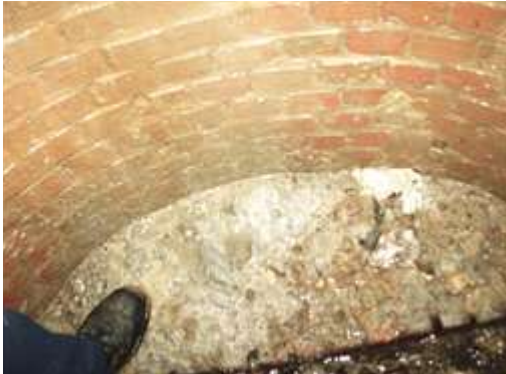
Defect 3

Channel Material: **Brick** ☐ Parged
Channel Exposure: **Fully Open** Junc Dist: **0** nearest .5 ft. Azimuth:
Condition: ☐ Sound ☐ Cracked ☐ Root Intrusion ☐ Deteriorated ☐ Leaks ☒ **Debris**

debris

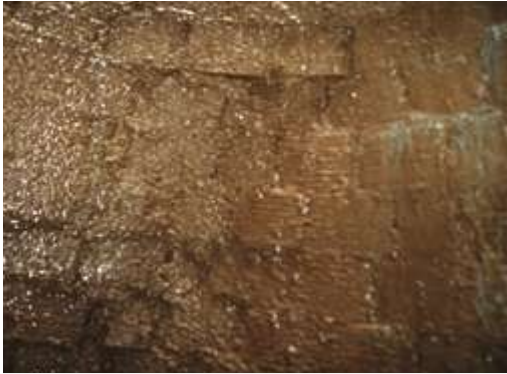
Defect 2

Corbel Material: **Brick** ☐ Parged Type: **Concentric/Eccentric**
Condition: ☒ Sound ☐ Cracked ☐ Root Intrusion ☐ Loose Brick ☐ Deteriorated
Infiltration: ☐ None ☐ Joint ☐ Cracks ☒ **Mortar** ☐ Roots ☐ Wall

infiltration

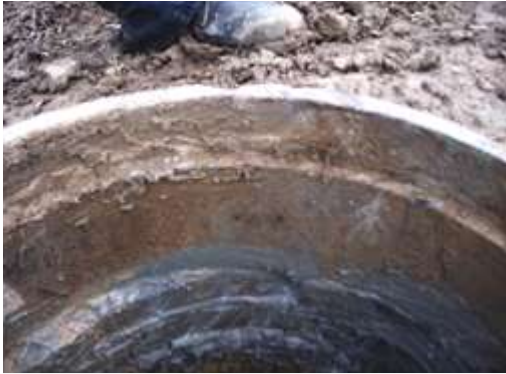
Defect 1

Frame Offset: **0** (in.) Condition: ☐ Sound ☐ Cracked ☒ **Leaks**

frame leaks

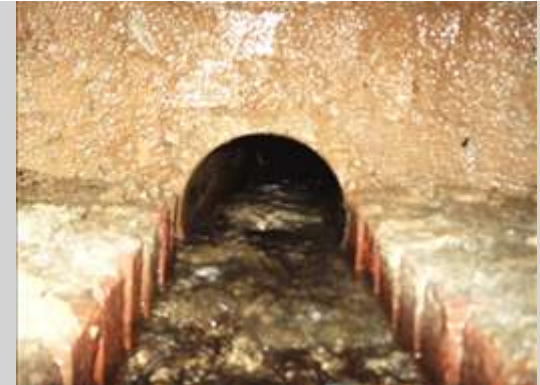
12 O'Clock Outflow

8 in. Circular Gravity Sewer
Pipe Out @ 12 O'Clock

Pipe Height: **12** (in.) Rod and Bar (Angled)
Pipe Material: **Clay** ☐ Pipe Lined
Invert Depth: **17.25** (ft.) Flow Characteristics: **Slow**
Deposits: ☒ None ☐ Mud ☐ Sludge ☐ Debris ☐ Grease
Silt Depth: (in.) Deposits Extent:
Infiltration: **None** Pipe Seal Cond: **Sound**

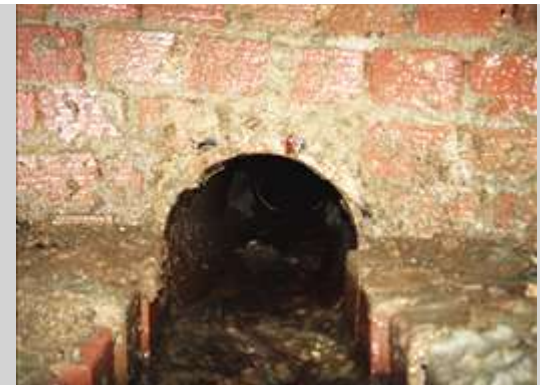
6 O'Clock Inflow

8 in. Circular Gravity Sewer
Pipe In @ 6 O'Clock

Pipe Height: **12** (in.) Rod and Bar (Angled)
Pipe Material: **Clay** ☐ Pipe Lined
Invert Depth: **17.00** (ft.) Flow Characteristics: **Slow**
Deposits: ☒ None ☐ Mud ☐ Sludge ☐ Debris ☐ Grease
Silt Depth: (in.) Deposits Extent:
Infiltration: **None** Pipe Seal Cond: **Sound**
